WRDC-TR-89-4055

COMPENDIUM OF FRACTOGRAPHIC DATA FOR COMPOSITE  
MATERIALS

INTERIM REPORT  
Covering 9-22-86 through 10-31-88

C. Hua  
M. Yamashita  
Boeing Advanced Systems  
P.O. Box 3707  
Seattle, WA 98124

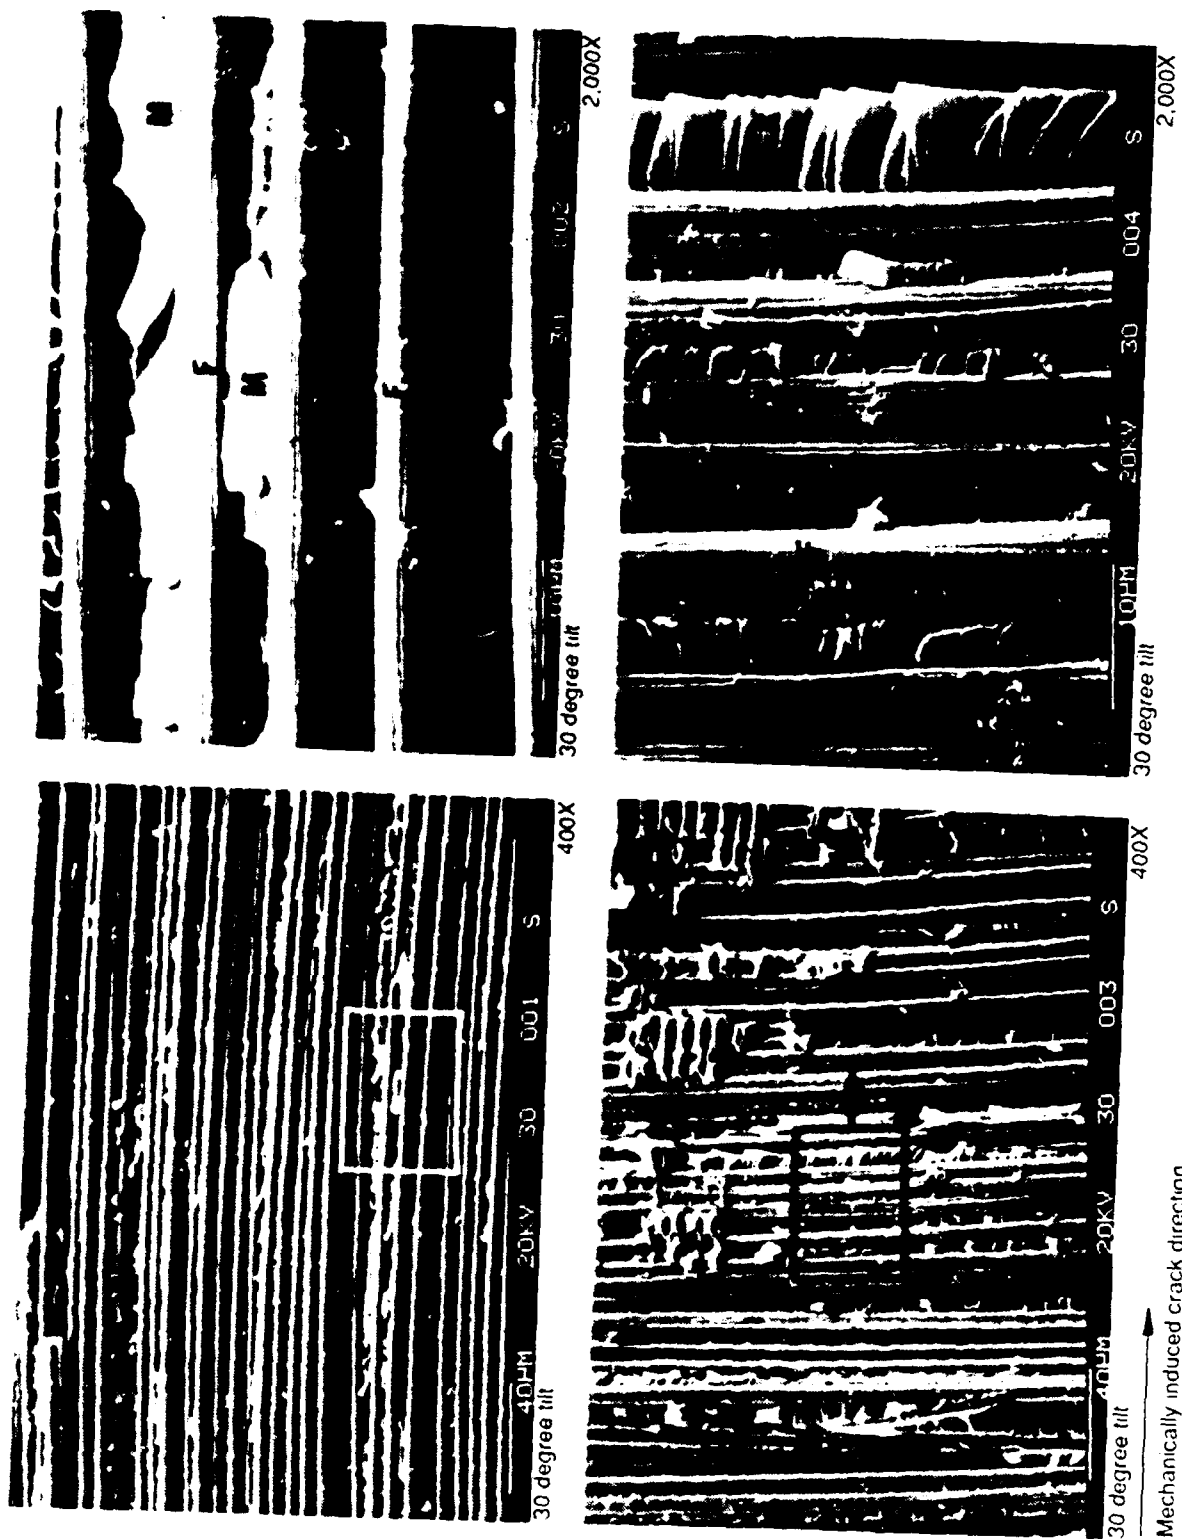
Figure 4.4-96 SEM Fractographs of 500 F/Dry, Mode I Fracture in C3K 8-HS/PMR-15

Interlaminar Mode I Tension, 500°F/Dry. Optical examination revealed a slightly reflective interlaminar surface. SEM fractography of tows perpendicular to the crack propagation direction revealed rivermarks indicating propagation in directions both consistent with and opposite to the overall propagation direction (Fig. 4.4-96). Fractography of tows parallel to the crack propagation direction revealed a featureless matrix fracture having the appearance of shear failure. Fiber/matrix adhesion was good.

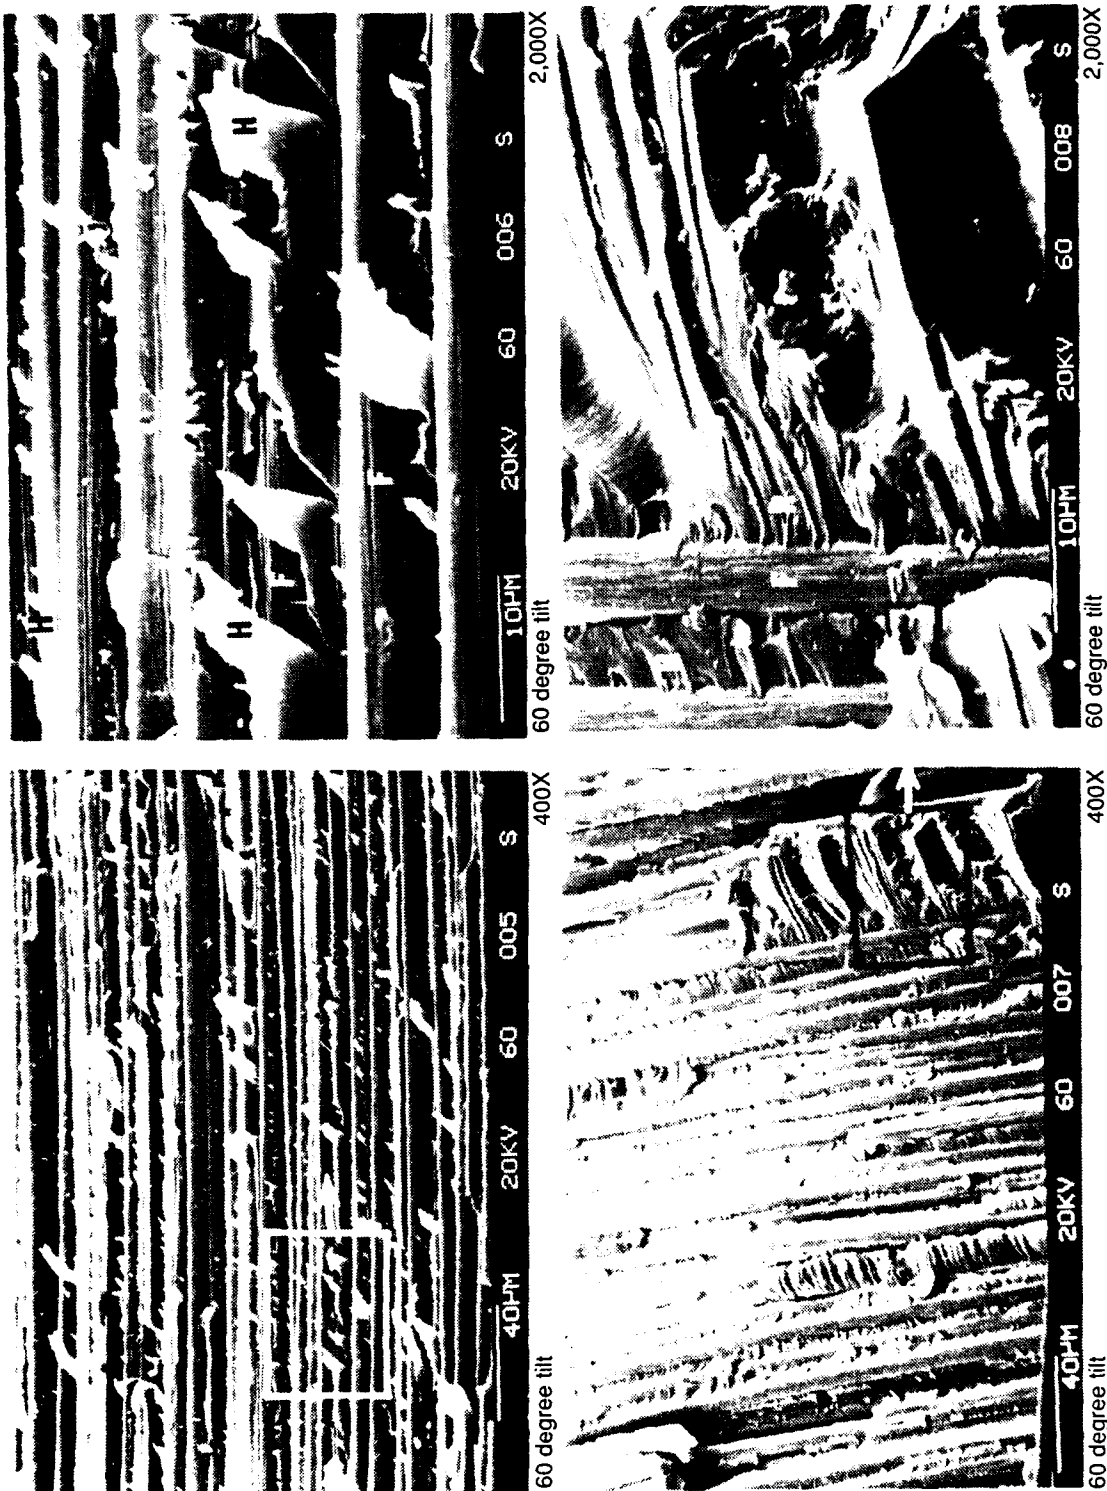
Figure 4.4-97 SEM Fractographs of Room Temperature, Mode II Fracture in C3K 8-HS/PMR-15

Interlaminar Mode II Shear, RT/Dry. Optical examination revealed a matte surface corresponding to the shear fracture. SEM fractography of tows parallel to the mechanically induced crack revealed hackles and scallops, indicative of shear fracture (Fig. 4.4-97). Fractography of tows perpendicular to crack propagation revealed a mixed-mode morphology. The cleavage features associated with the observed hackles did not indicate crack propagation in the induced direction. The fiber/matrix adhesion was poor.

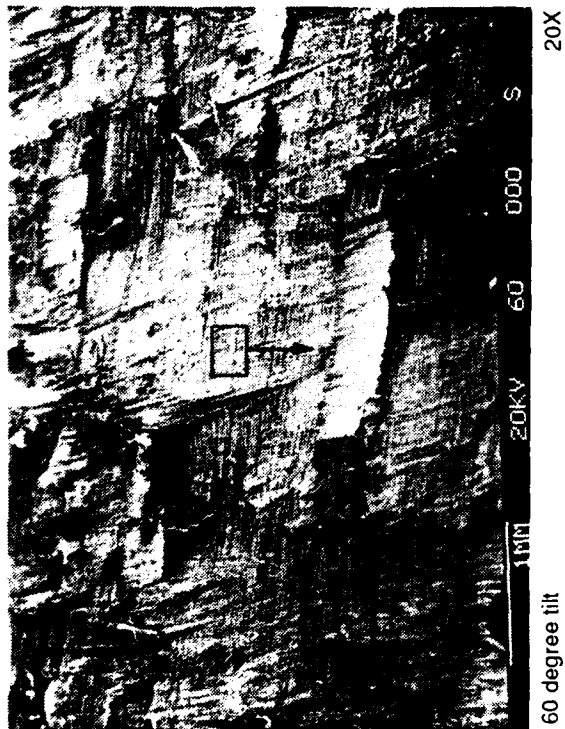
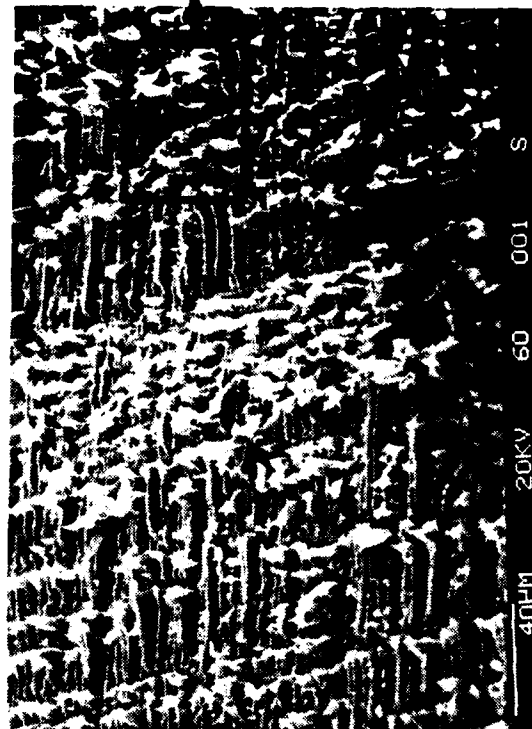
Figure 4.4-98. SEM Fractographs of 500 F/Dry, Mode II Fracture in C3K 8-HS/PMH-15

Interlaminar Mode II Shear, 500°F/Dry. Optical magnification of the interlaminar shear fracture did not reveal the regular dull, matte surface or milky white appearance associated with Mode II shear fractures. SEM fractography revealed hackles and scallops on both the parallel and perpendicular tows (Fig. 4.4-98). Crack propagation direction could not be determined. Fiber/matrix adhesion was good.

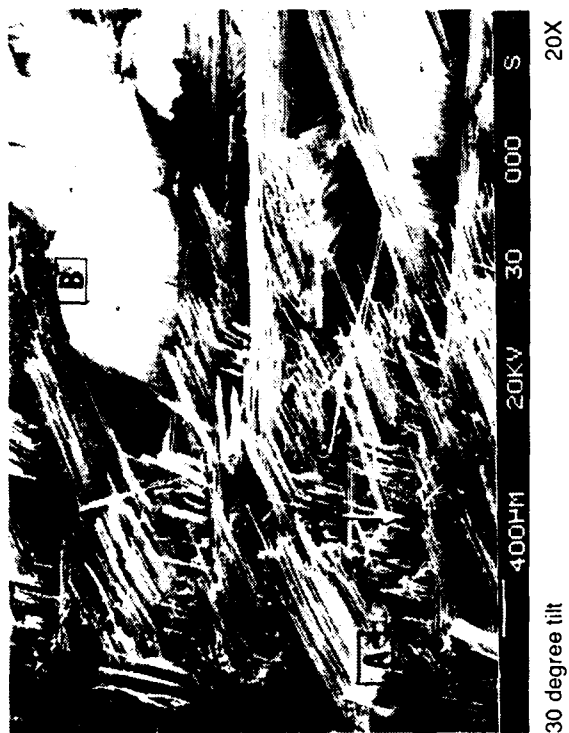
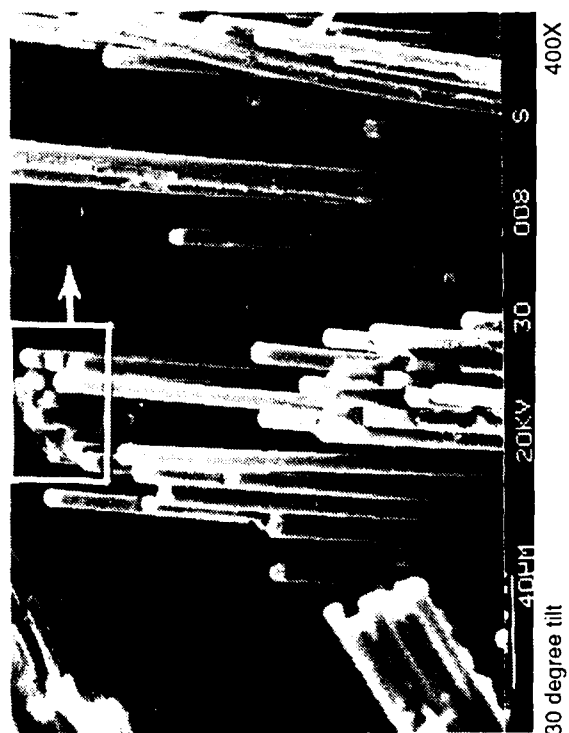
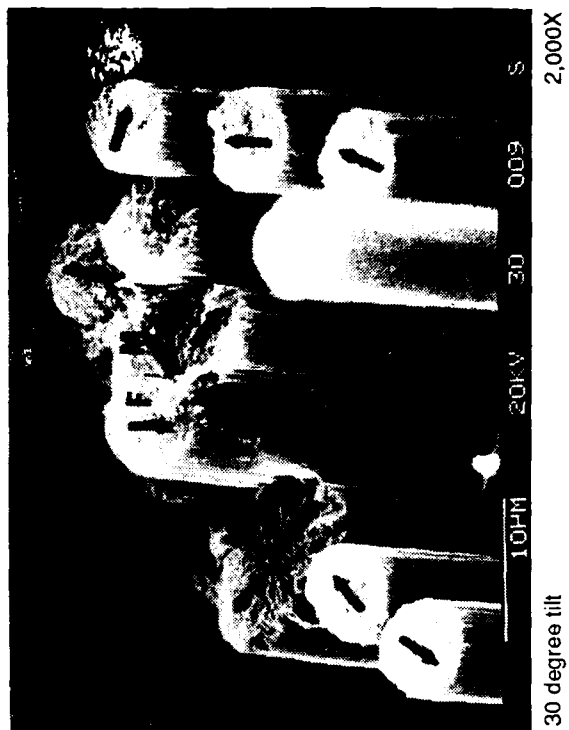
Figure 4.4-99. SEM Fractographs of Room Temperature/Dry, Translaminar Tension Fracture in C3K 8-HS/PMR-15

Translaminar Tension, RT/Dry. Visual examination revealed tensile failure. SEM fractography of the tensile portion revealed fiber end features with fan patterns showing an overall propagation direction consistent with the mechanically induced crack direction (Fig. 4.4-99). Rivermarks and resin microflow in the resin-rich areas of the tensile zone also indicated crack growth direction consistent with the mechanically induced crack direction.

A substantial amount of 45 degree fibers were observed protruding from the surfaces. Fibers oriented at +45 degree were observed from one fracture surface and -45 degree fibers from the mating fracture surface. This condition is expected with tensile loading.

Macroscopically, the fractures appeared jagged due to the protruding plies. The most outstanding feature was the multitude of individual fibers protruding from the tensile loading. Due to the high fiber content utilized in carbon/PMR-15, fiber/matrix adhesion was poor and extensive fiber pullout was observed.

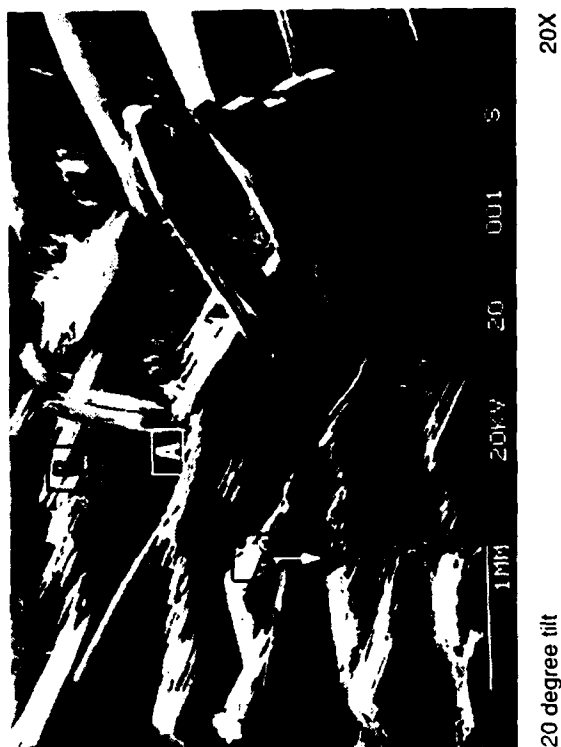
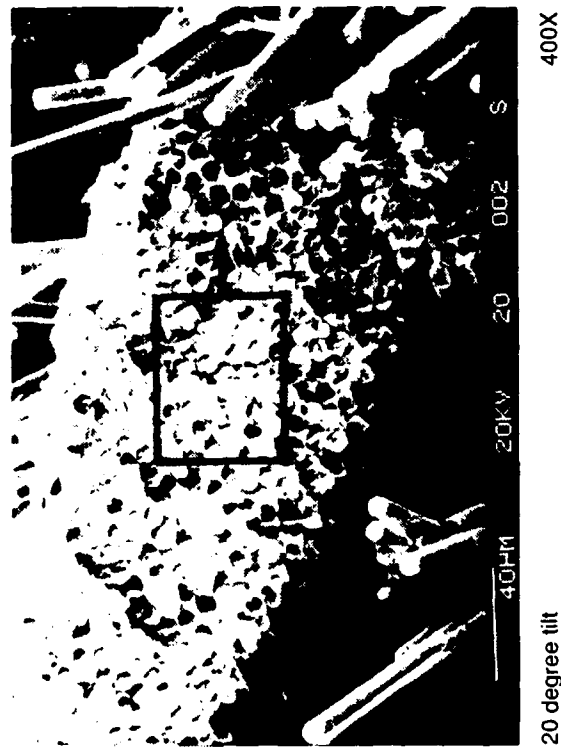
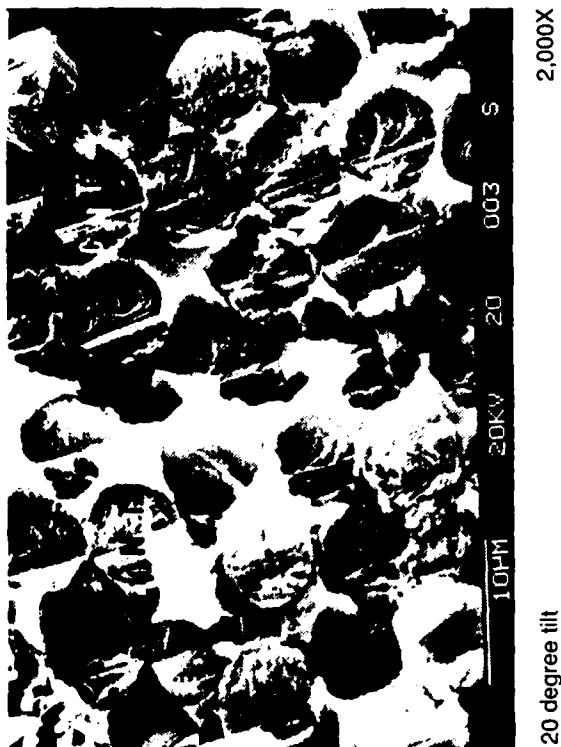
Figure 4.4-101. SEM Fractographs of Room Temperature/Dry, Translaminar Compression Fracture in C3K 8-HS/PMR-15

Translaminar Compression, RT/Dry. Optical examination revealed both tensile and compressive regions, as was found on the translaminar tension specimens (Fig. 4.4-101). The compressive zone in this specimen was approximately a third of the fracture surface with the remainder being tensile. The compressive loading appeared to have initiated a tensile crack on the opposite surface which propagated toward the notch and intersected the compressive damage; SEM examination of the tensile portion revealed fiber end fractures that indicated propagation toward the opposite side. (In these specimens, the specified mechanically induced crack direction is from the notch outward). The compressive region revealed a debris-covered surface with fiber end fractures containing both tensile and compressive zones. Resin-rich fractures in the tensile zone revealed rivermarks, indicating propagation opposite to the mechanically induced crack direction, as expected.

As in the translaminar tension specimens, plies oriented at 45 degree were observed protruding from the fracture surface. However, plies oriented at both +45 and -45 were observed on each fracture surface, with the +45 degree plies dominating. Delaminations were observed in these protruding plies.

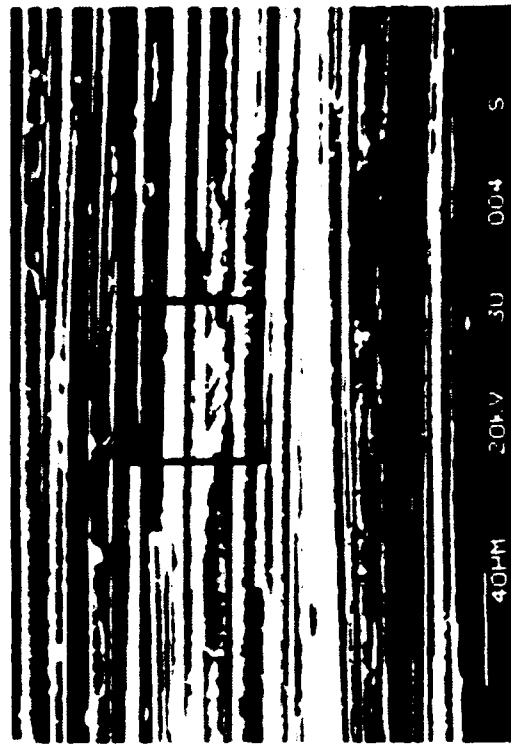
Figure 4.4-103. SEM Fractographs of Room Temperature Dry, Interlaminar Mode I Tension Fracture in IM 7/8551

Interlaminar Mode I Tension, RT/Dry. Optical examination revealed a smooth, reflective, mostly interlaminar fracture surface. Between plies, the epoxy and toughening phases were distinguishable. SEM fractography revealed rivermarks between fibers that had a longitudinal component consistent with the mechanically induced crack direction (Fig. 4.4-103). Fractography of the resin-rich region between plies revealed rivermarks in the epoxy, propagating around toughener particles. These rivermarks indicated crack growth consistent with the mechanically induced crack direction. The toughener particles did not reveal indications of crack growth direction. Some evidence of ductile fracture was observed adjacent to the toughener particles. Fiber/matrix adhesion appeared to be good.

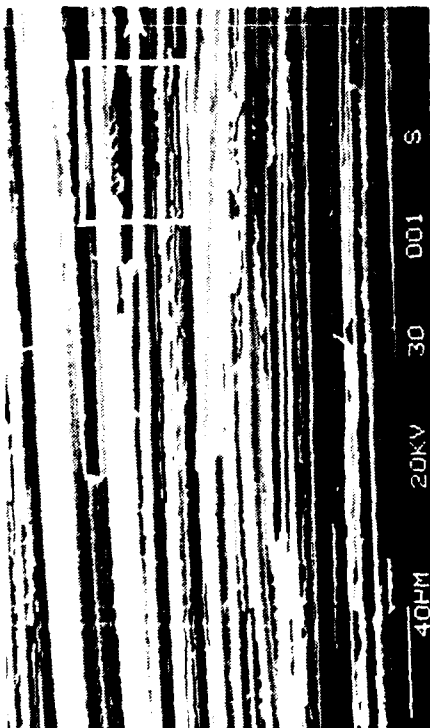
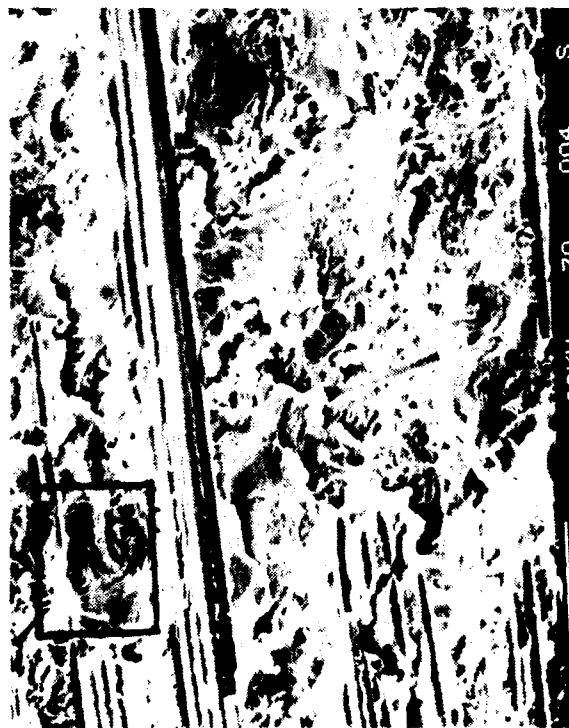
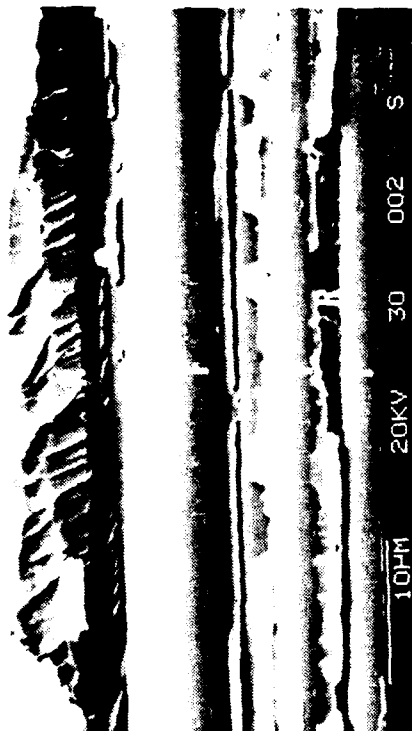
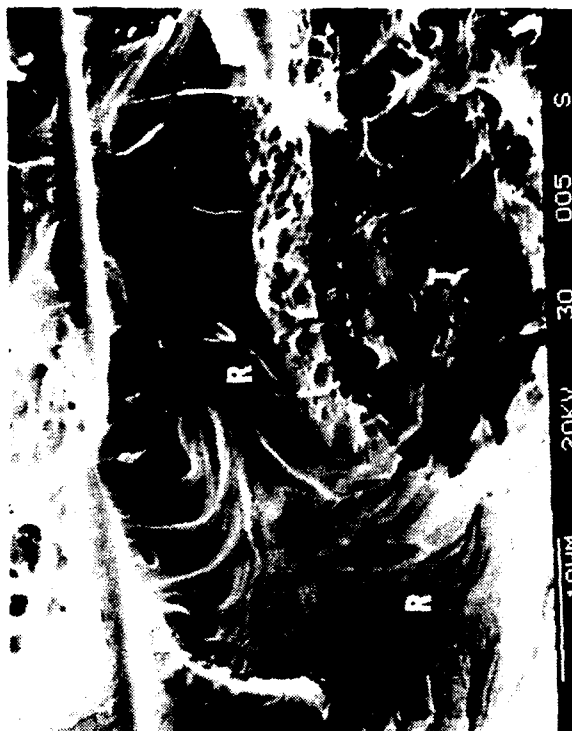
Figure 4.4-104. SEM Fractographs of 270 F/Wet, Interlaminar Mode I Tension Fracture in IM-7/8551

Interlaminar Mode I Tension, 270°F/Wet. Optical examination of the fracture revealed a reflective surface, typical of Mode I fractures. SEM examination revealed rivermarks between fibers indicating propagation consistent with the mechanically

induced crack direction (Fig. 4.4-104). Rivermarks found in the resin-rich areas between plies also indicated a propagation consistent with the mechanically induced crack propagation. Fiber/matrix adhesion was good.

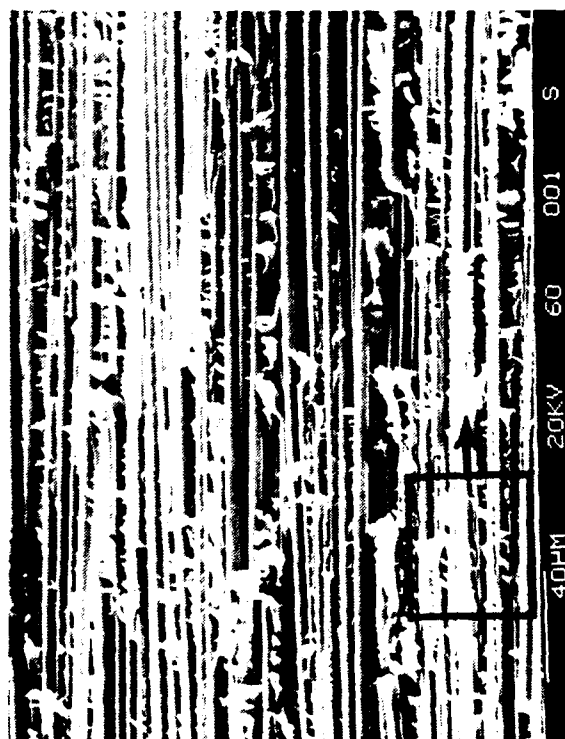
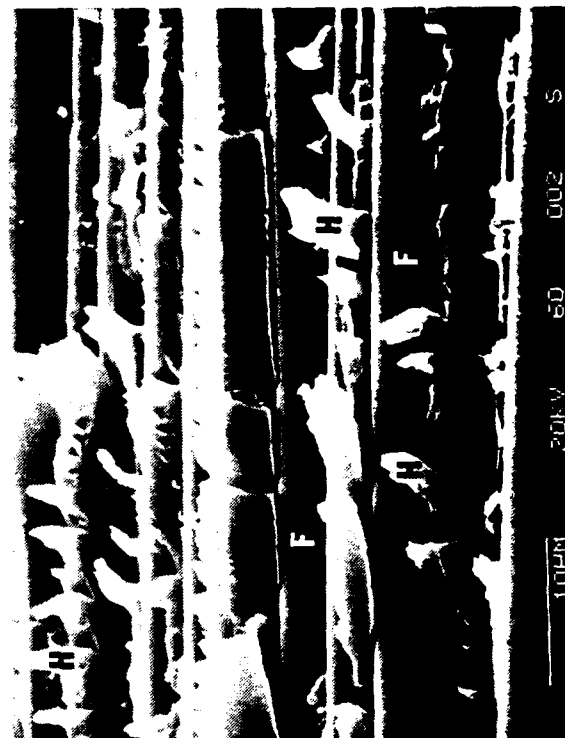
Figure 4.4-105. SEM Fractographs of Room Temperature, Interlaminar Mode II Shear Fracture in IM-7/8551

Interlaminar Mode II Shear, RT/Dry. Optical examination revealed typical Mode II shear fracture features. SEM fractography revealed hackles also typical of Mode II propagation (Fig. 4.4-105). Resin-rich regions between plies contained rivermarks indicating crack propagation in a direction consistent with the mechanically induced direction. These rivermarks are apparently the result of cracking through the ply due to offset crack planes. Bare fibers and matrix separation are normal for a shear failure.

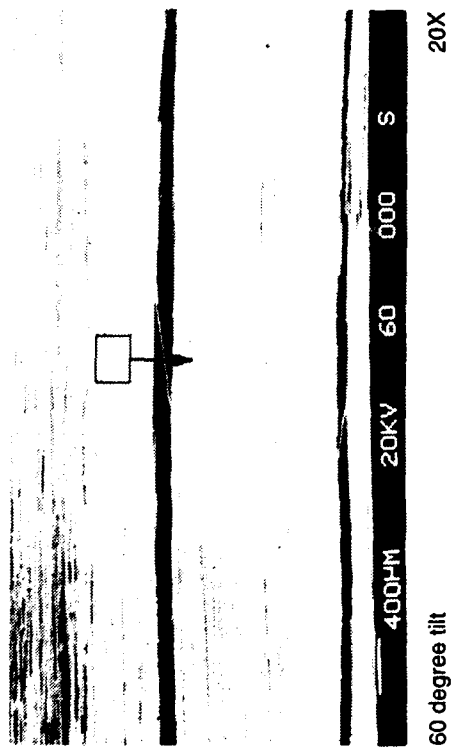
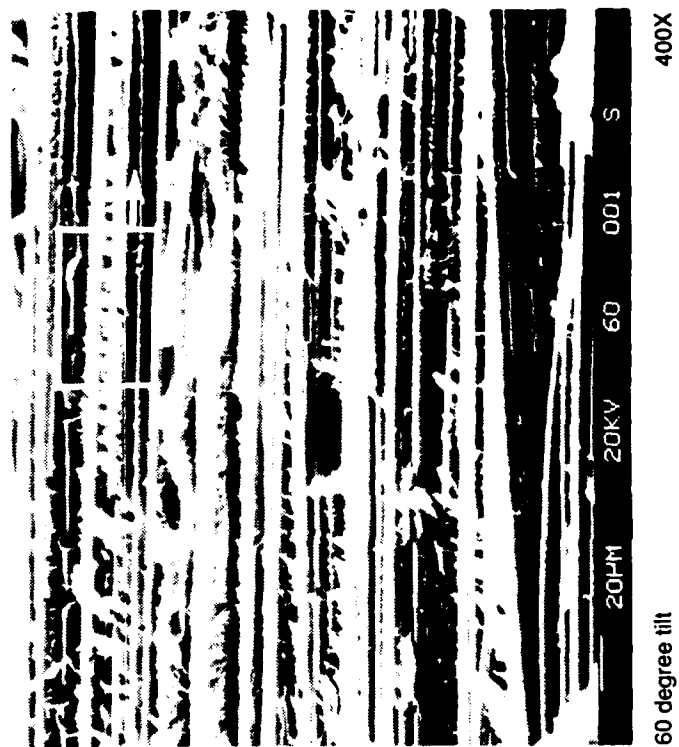
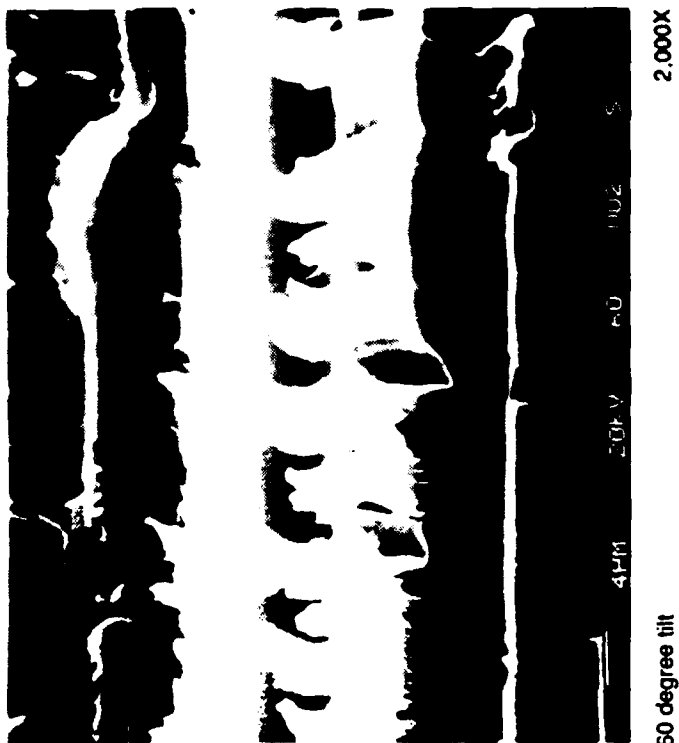
Figure 4.4-106. SEM Fractographs of 270 F/Wet, Interlaminar Mode II Shear Fracture in IM-7/8551

Interlaminar Mode II Shear, 270°F/Wet. Optical examination revealed a typical Mode II shear fracture. SEM examination of the fracture revealed hackles and scallops typical of Mode II fractures (Fig. 4.4-106). The direction of mechanically induced crack propagation could not be determined.

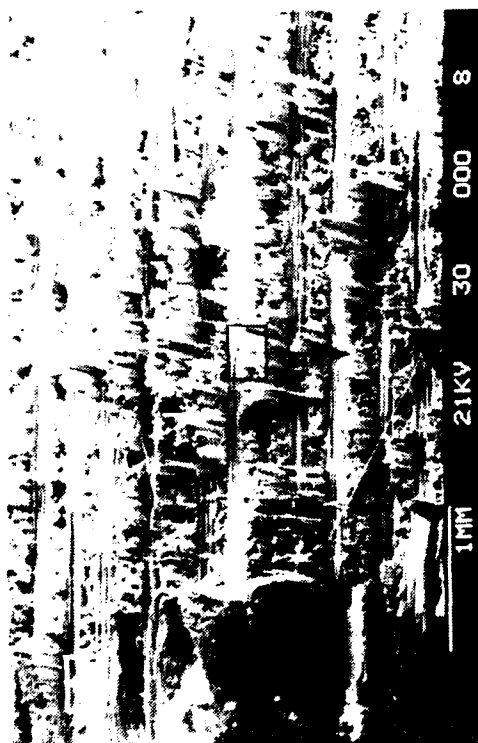
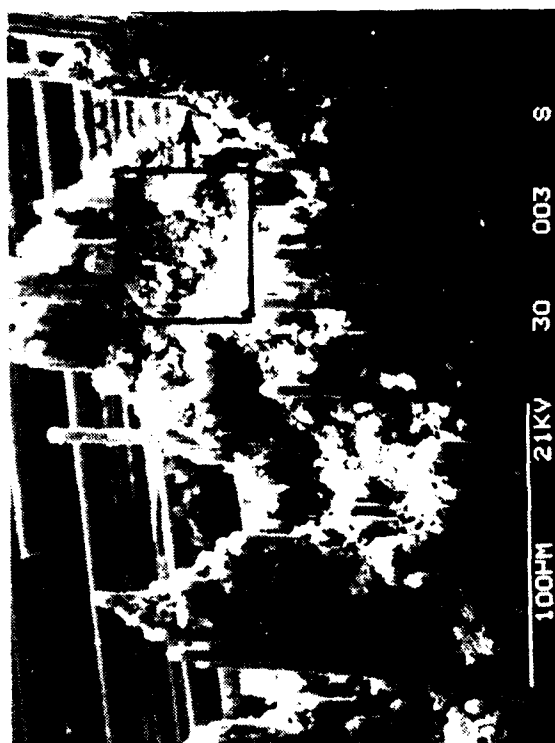
Figure 4.4-107. SEM Fractographs of Room Temperature, Translamellar Tension Fracture in IM-7/8551

Translaminar Tension, RT/Dry. Optical examination revealed a rough surface due to typical fiber pullout. SEM fractography revealed radial patterns on the fiber ends indicating a resultant crack direction consistent with the mechanically induced direction (Fig. 4.4-107). Fiber/matrix adhesion was good.

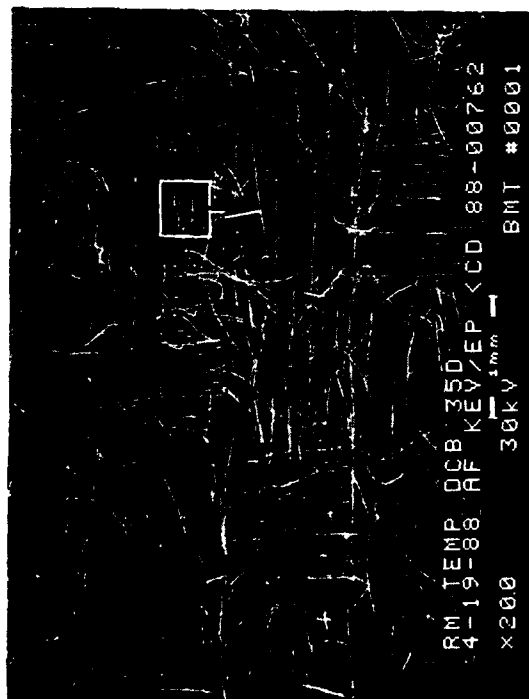
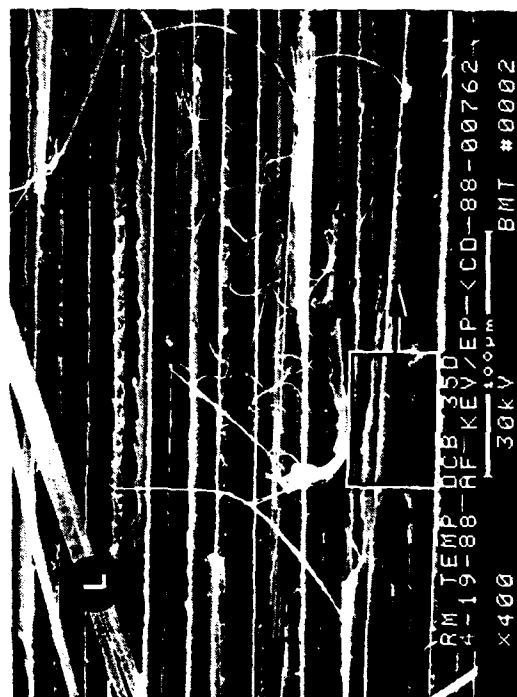
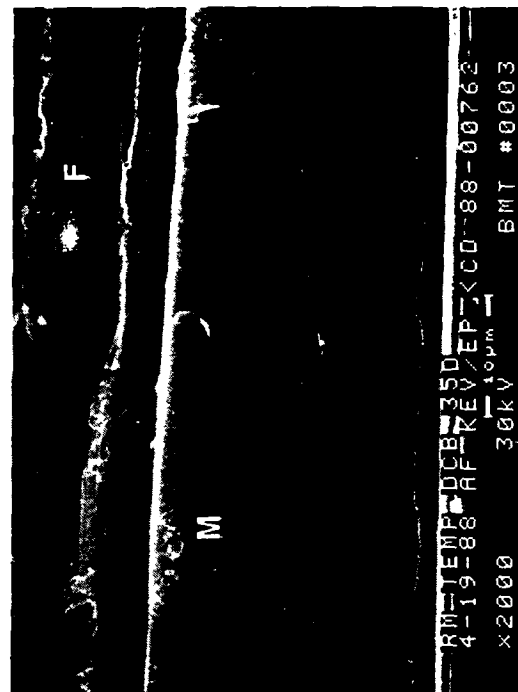
Figure 4.4-124. SEM Fractographs of Room Temperature, Interlaminar Mode I Tension Fracture in Kevlar/Epoxy (at the Center of the Weave)

Interlaminar Mode I Tension, RT/Dry. The RT/dry interlaminar fracture lacked rivermarks commonly observed in other epoxy-based interlaminar Mode I tension fractures (such as in glass or carbon-fiber reinforced specimens). There were no fracture features at the node or the center of the weave that could be used for determining the crack propagation direction (Fig. 4.4-124 and 4.4-125). The fiber/matrix adhesion was poor.

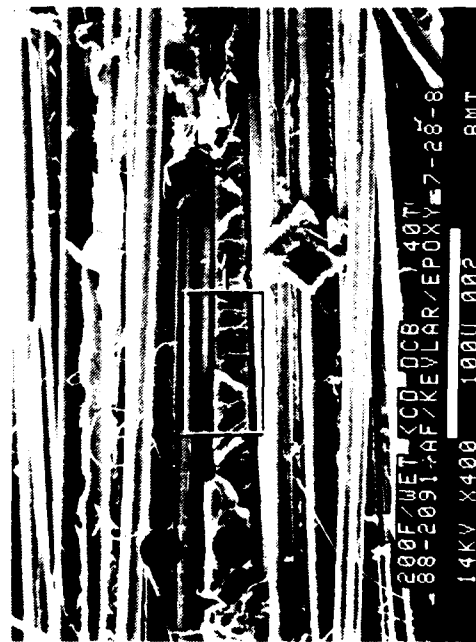
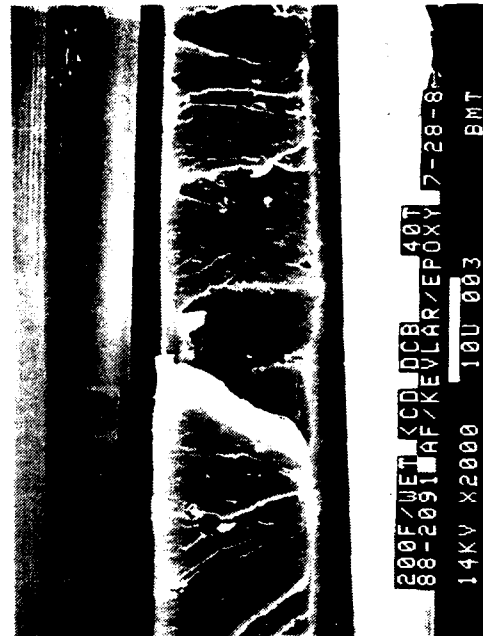
Figure 4.4-126. SEM Fractographs of 200 F/Wet, Interlaminar Mode I Tension Fracture in Kevlar/Epoxy

Interlaminar Mode I Tension, 200°F/Wet. Visual examination of the 200°F/wet interlaminar Mode I tension fracture revealed a smooth, shiny surface with patches of flakey resin on the fracture. The fractures of the RT/dry and 200°F/wet specimens appeared almost identical except for an apparent degradation in the patches of flakey resin on the 200°F/wet fracture. The fiber/matrix adhesion was poor as evidenced by the smooth fracture with fiber imprints. The difference between the RT/dry and the 200°F/wet specimens was the greater extent of fiber pullouts and fiber imprints in the 200°F/wet. This indicated weaker fiber/matrix adhesion than in the RT/dry specimen (Fig. 4.4-126).

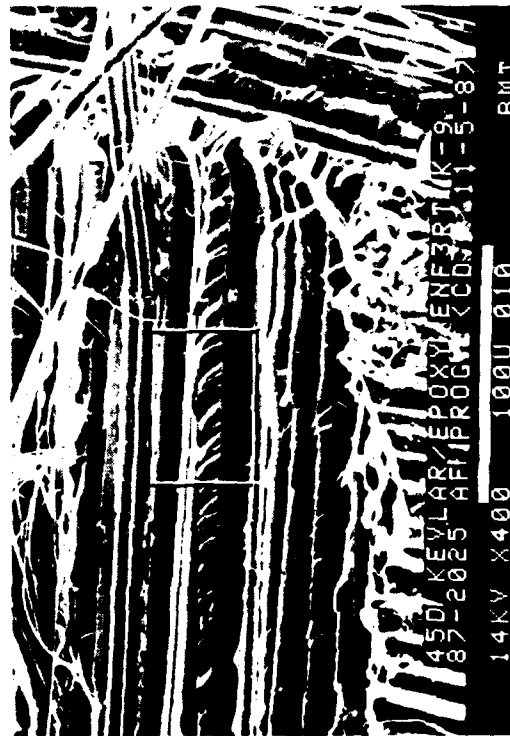
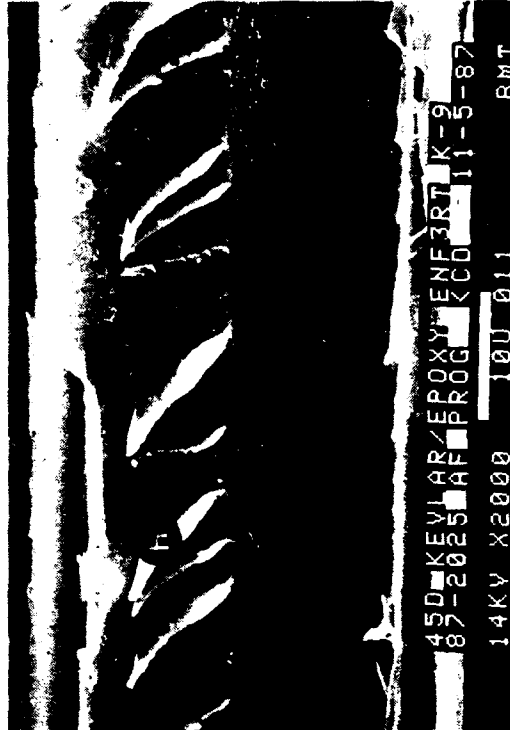
Figure 4.4-127. SEM Fractographs of Room Temperature, Interlaminar Mode II Shear Fracture in Kevlar/Epoxy Fabric

SEM analysis showed hackle formation and an adhesive-type fracture evidenced by the clean and smooth imprints of the fibers (Fig. 4.4-127).

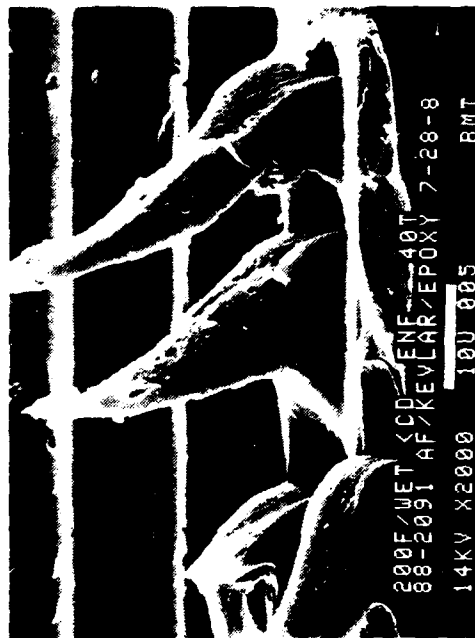
Figure 4.4-128. SEM Fractographs of 200 F/Wet, Interlaminar Mode II Shear Fracture in Kevlar/Epoxy

Interlaminar Mode II Shear, 200°F/Wet. Visual examination of the interlaminar Mode II shear 200°F/wet fracture revealed a dull, rough surface similar to that of the RT/dry fracture. In addition, there were large tears in the fracture surface from what appears to have been a high energy fracture (Fig. 4.4-128). The energy of this fracture may have been due to the increase in toughness of the resin matrix due to the moisture exposure. The hackles were formed in a ductile fashion evidenced by the taffy-pull type fracture (commonly observed in metal fractures). This type of microscopic fracture behavior is due to an intrinsic characteristic of the epoxy matrix, which becomes more ductile when exposed to elevated temperature and humidity. The fiber/matrix adhesion was poor as evidenced by the smoothness of the resin fracture and the fiber imprints. A greater extent of fiber pullout (due to weak fiber/matrix adhesion) and more distinct hackles were observed in the 200°F/wet specimen than in the RT/dry specimen.

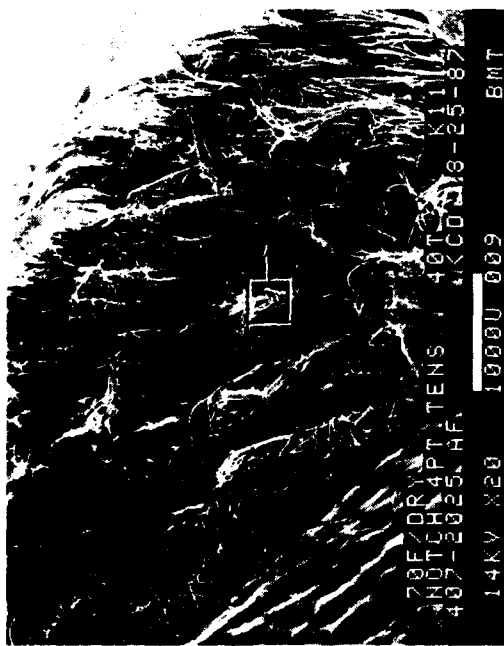
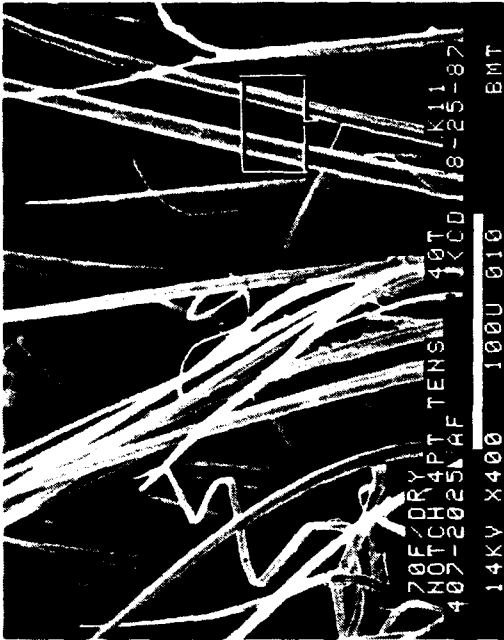
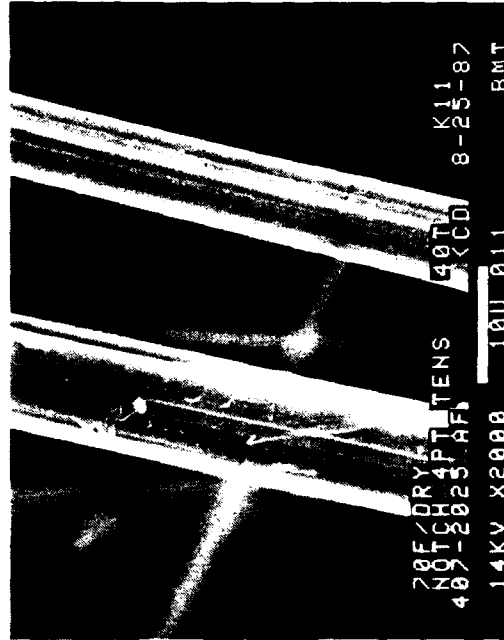
Figure 4.4-129. SEM Fractographs of 70 F/Dry, Translaminar Tension, 0/90 Fracture in Kevlar/Epoxy

Translaminar Tension, RT/Dry. Visual and optical observation revealed a broom-like fracture surface indicating extensive fiber-dominated fracture. Under SEM, the fiber/matrix interface showed a very smooth surface and the fiber ends showed no sign of any crack direction (Fig. 4.4-129).

Both RT/dry and 200°F/wet specimens showed broom-like fibrillation of the Kevlar fibers. The Kevlar fibers failed differently than glass and carbon fibers. The radial pattern commonly observed in glass and carbon fibers, which provides information to determine the overall crack direction, was absent. The fiber/matrix interface showed a very smooth surface with poor adhesion in both cases.

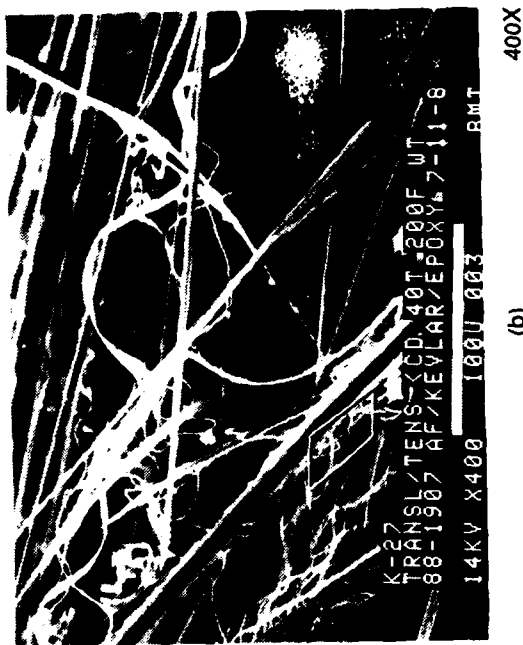
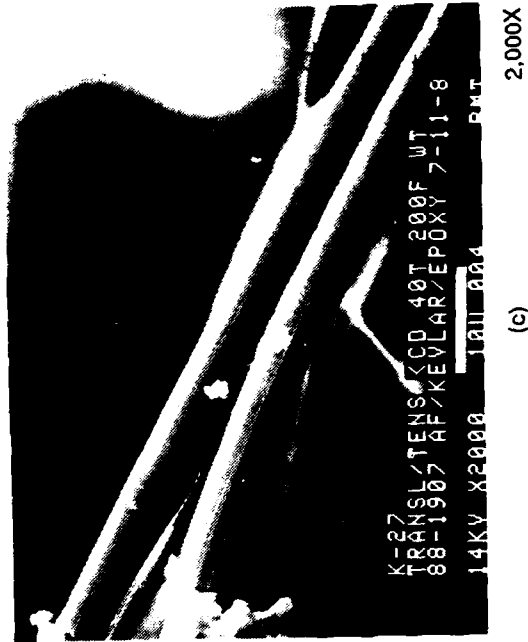
Figure 4.4-130. SEM Fractographs of 200 F/Wet, Translamellar Tension Fracture in Kevlar/Epoxy

Translaminar Tension, 200°F/Wet. Figure 4.4-130 shows the SEM fractographs of a 200°F/wet translaminar tension fracture exhibiting a similar appearance to the RT/dry fracture, with no observable features, to differentiate environmental effects.

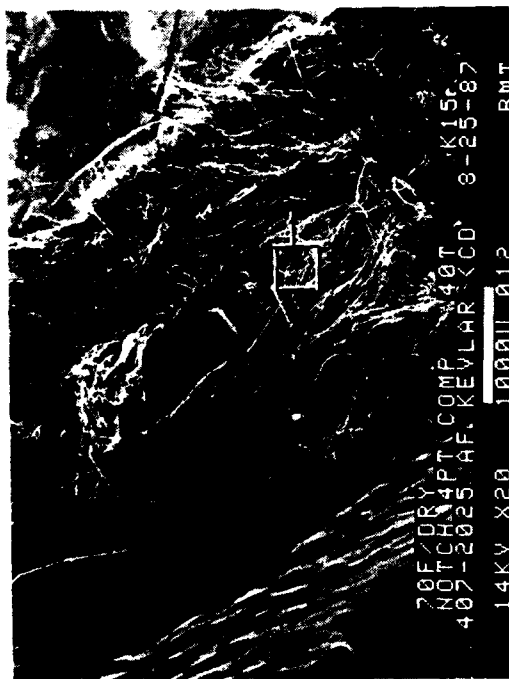
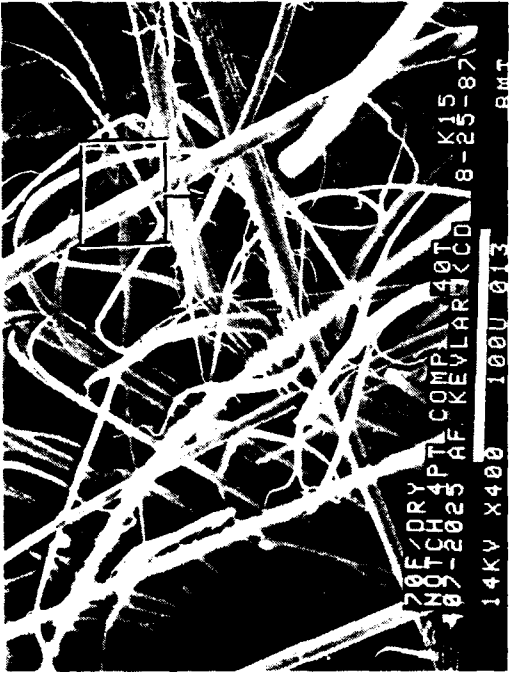
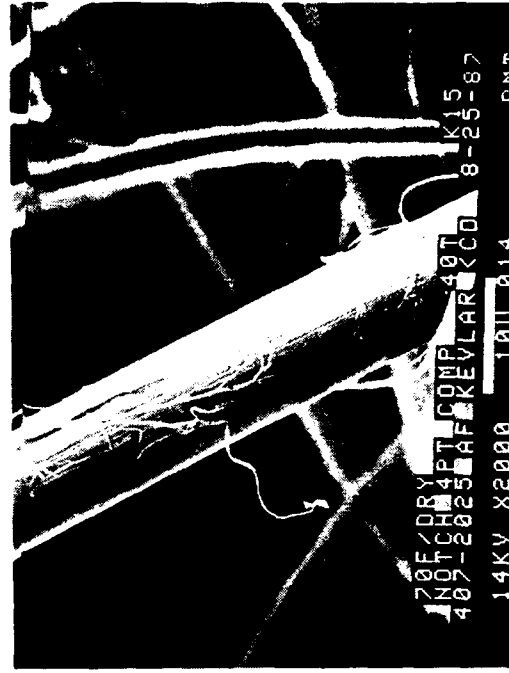
Figure 4.4-131. SEM Fractographs of 70 F/Dry, Translaminar Compression, 0/90 Fracture in Kevlar/Epoxy

Translaminar Compression, RT/Dry. Visual, optical, and SEM observations revealed a broom-like fracture surface with the protruding fibers twisted in all directions (Fig. 4.4-131).

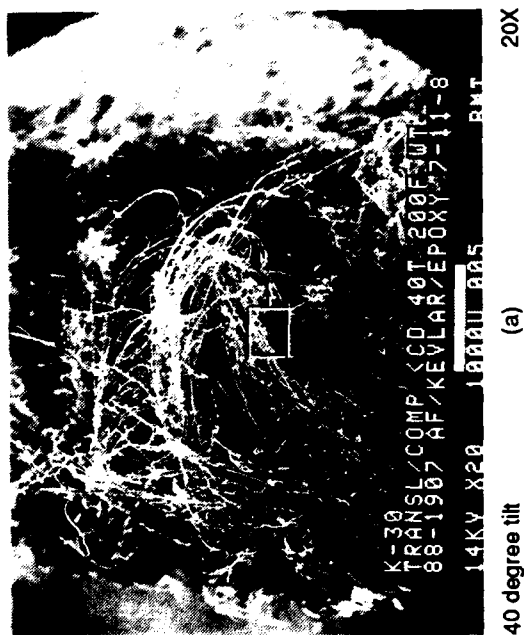
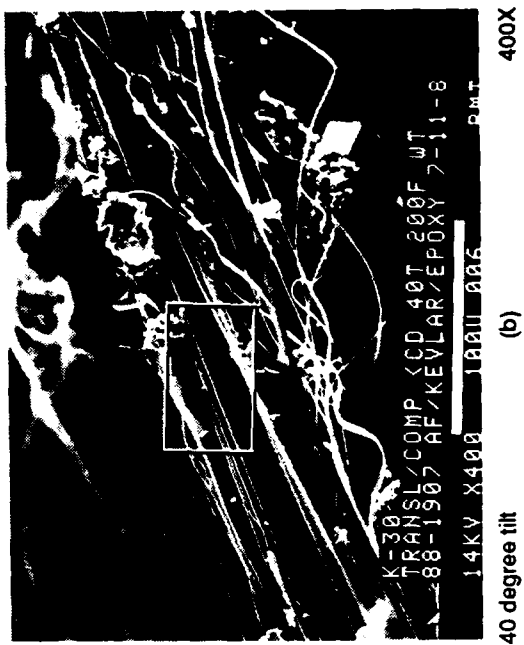
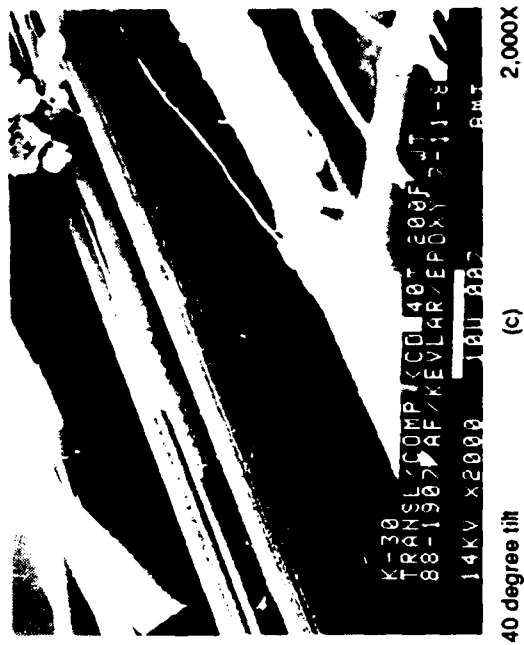
Figure 4.4-132. SEM Fractographs of 200 F/Wet, Translamellar Compression Fracture in Kevlar/Epoxy

Translaminar Compression, 200°F/Wet. Figure 4.4-132 shows the SEM fractograph of a translaminar Mode I compression, Kevlar/epoxy, 200°F/wet specimen. As in the translaminar Mode I tension specimen, the RT/dry and the 200°F/wet translaminar compression specimens exhibited similar fracture appearances and there was no distinguishable feature to differentiate the environmental effects. The debris on the fibers was mostly due to the wet cutting of the specimen.

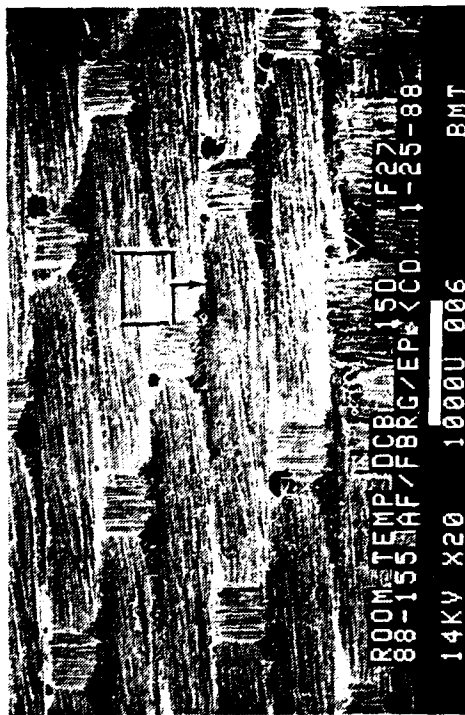
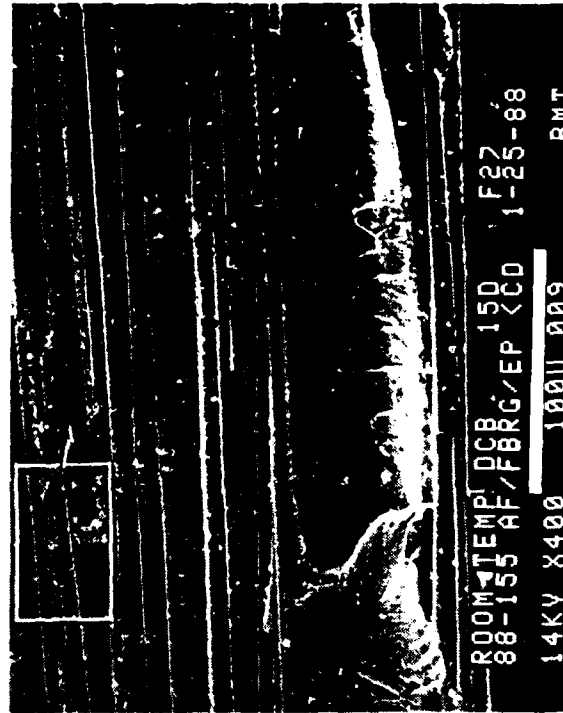
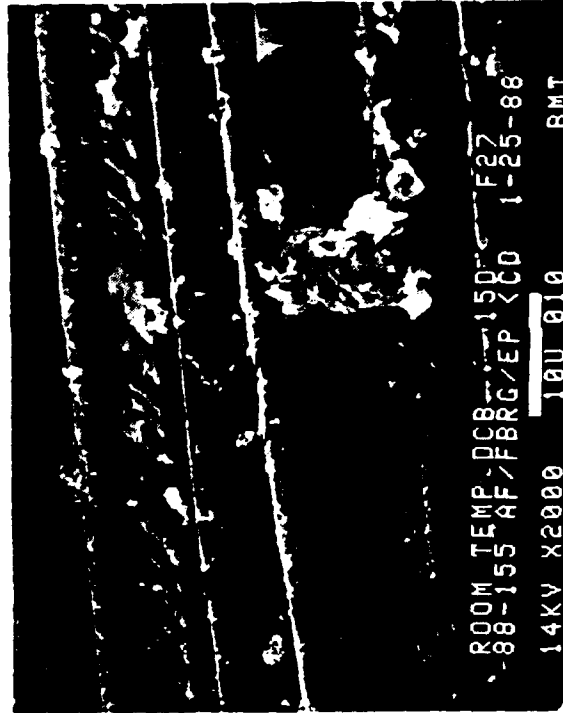
Figure 4.4-133. SEM Fractographs of Room Temperature, Interlaminar Mode I Tension Fracture in Fiberglass/Epoxy

Interlaminar Mode I Tension, RT/Dry. Visual observation of the fracture revealed a smooth, glassy surface. Optical photomicrographs were not taken because of the transparency of the fiberglass/epoxy. Cleavage markings, (rivermarks) typically seen in Mode I tension fractures of carbon fiber reinforced epoxies were observed under the SEM (Fig. 4.4-133). These features were usually observed at the nodes where the weaves overlap one another. The fiber/matrix adhesion appeared to be poor at some locations. This is due to the low inherent interfacial shear strength at the fiberglass/epoxy interface.
